Aviation Safety

Ultralight and Balloon

Issue 1/2000

Some Tips on Ultralight Pre-flight/Maintenance

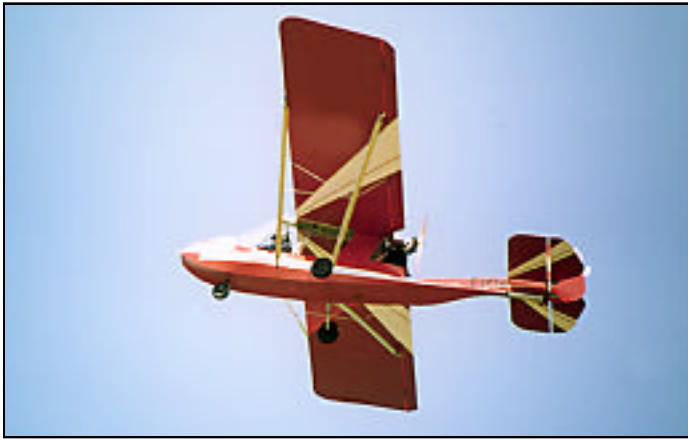
The Challenger ultralight shown above is similar to the Challengers involved in the accidents mentioned. This is a unique aircraft designed specifically for very slow flight operation and, as such, it has unique flying and control characteristics. For your safety, obtain dual training and experience prior to attempting solo flight in this aircraft type.

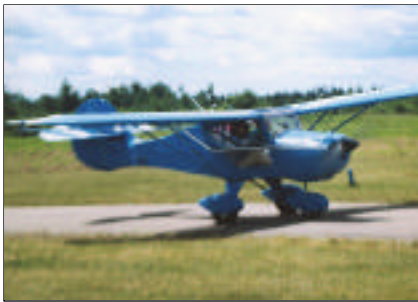
The Avid Flyer type aircraft (above) is widely in use throughout the world and in Canada. As with any aircraft type, as the numbers increase so do the accidents and incidents. I have compiled a synopsis of a number of cases for this article from various data bases, including those from Canada, the U.S. and New Zealand. Human factors appear to play a major role in both the maintenance and handling of the aircraft. As you read these incidents and comments, think of changes you can make in your maintenance and flight operation to avoid repeating past mistakes. Often, the engine type is not listed in the reports so it is difficult to find a pattern for the engine failures. It is also difficult to know whether the failures involve more than one type of engine. It is assumed that most of the Avid Flyers were equipped with Rotax engines. Some typical incident/accident descriptions follow, with safety points in **bold** :
